**An Assessment of Landslides along Mountain Forest
Roads: Bamenda Ring Road Segment through Bafut and
Befang Forests on the Cameroon Volcanic Line.**

E.M Amah, V.Y. Katte, R.T Ghogomu and V.K Kamgang

Keywords: *Landslides, Bafut, Befang, Bamenda Ring Road, CVL, road defects.*

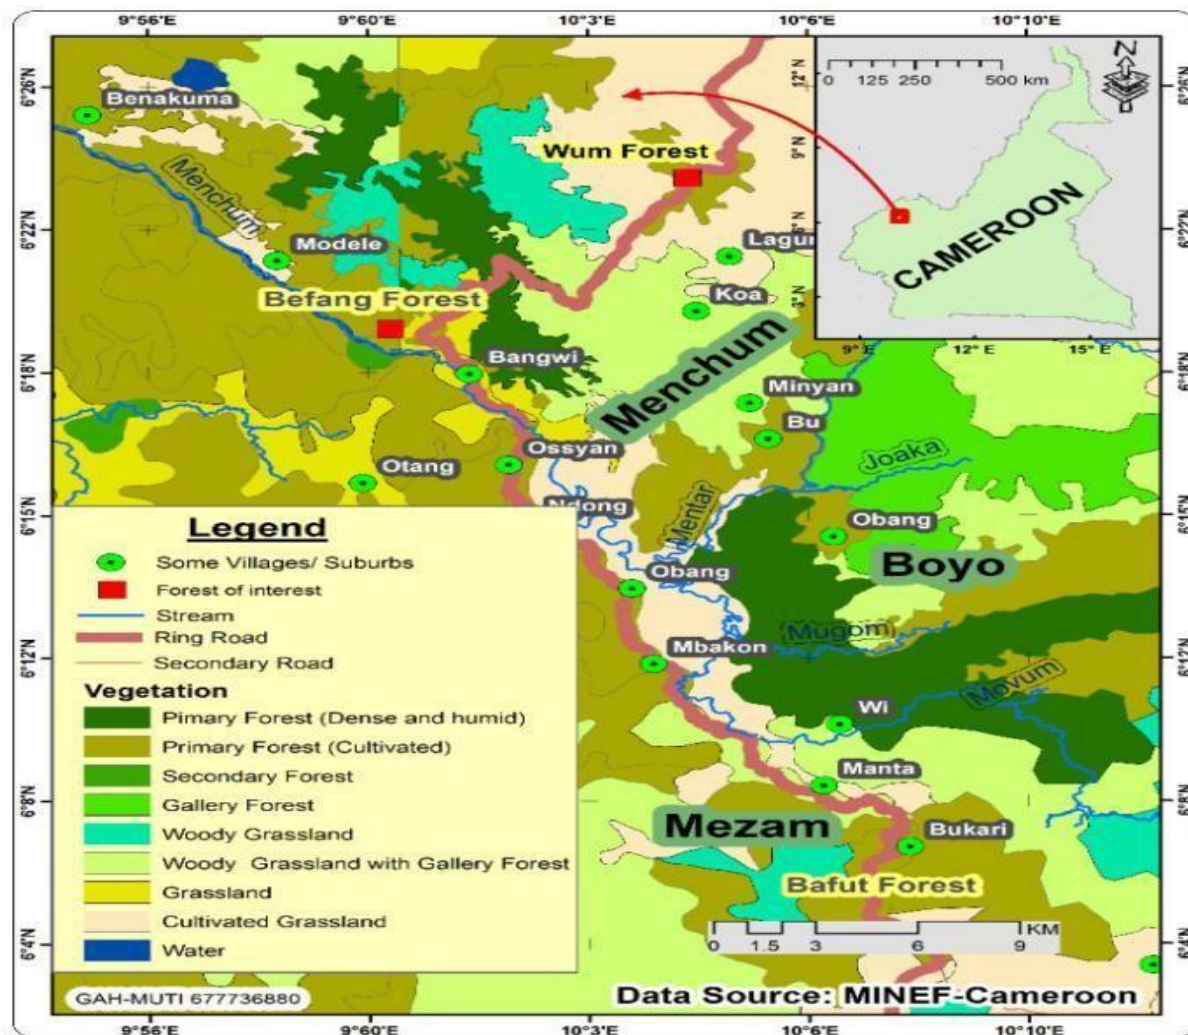
Figure 2: Road / Vegetation Map of Bafut-Wum area

A comprehensive study of road and vegetation maps published by Hof *et al.*, (1983) and the Ministry of Environment and Forest (MINEF) (Fig 2), detailing the segment of the BRR through the Bafut Forest and the Befang Forest was carried out. Base topographic maps (Bafoussam 1:200.000 edited in 1978 Bafoussam 3C and Nkambe 1A and 1C) published by National Geographic Centre – Yaounde and lodged today at the National Institute of Cartography, Yaounde were consulted. A broad study of a number of satellite images; Google Earth, ASTER, Sentinell, Landsat 7 ETM, and SPOT was also carried out. The topographic base maps and the satellite images enabled us to obtain a map (figure 3) of the BRR and a 3D of the topographic and relief structure of the area as shown in figure 4.

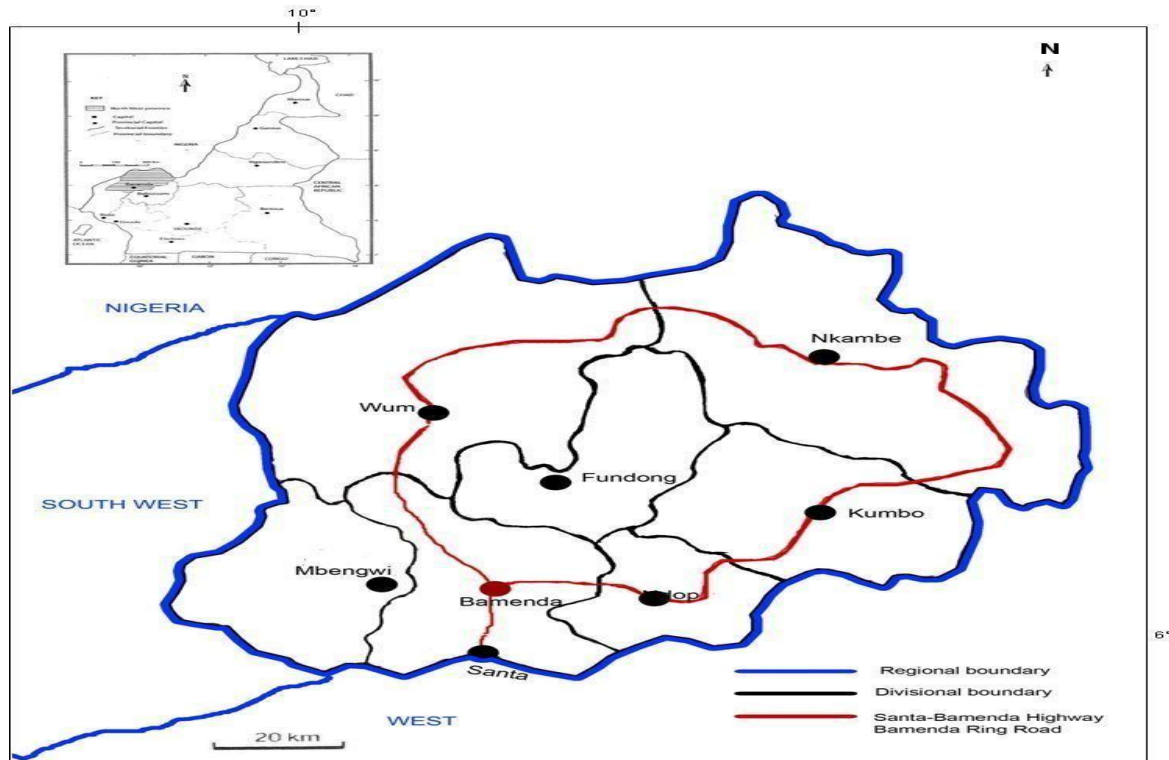
Figure 3: Bamenda Ring Road

Within the labyrinth of the hilly and mountainous CVL landscape lies a dense network of roads of which the BRR constitutes the backbone (figure 3). Following the descriptions of Kellar and Sherar (2003) and Hearn (2007) on low-cost, low-volume roads, the BRR was built and constructed accordingly with some stretches having been paved. The BRR from Njinteh-Bafut to Wum goes through the Bafut and Befang Forests (figure 2) covering a distance of 62 km. The Bafut Forest stretch goes from Njinteh to Tingoh 12.5 km and the Befang Forest stretch

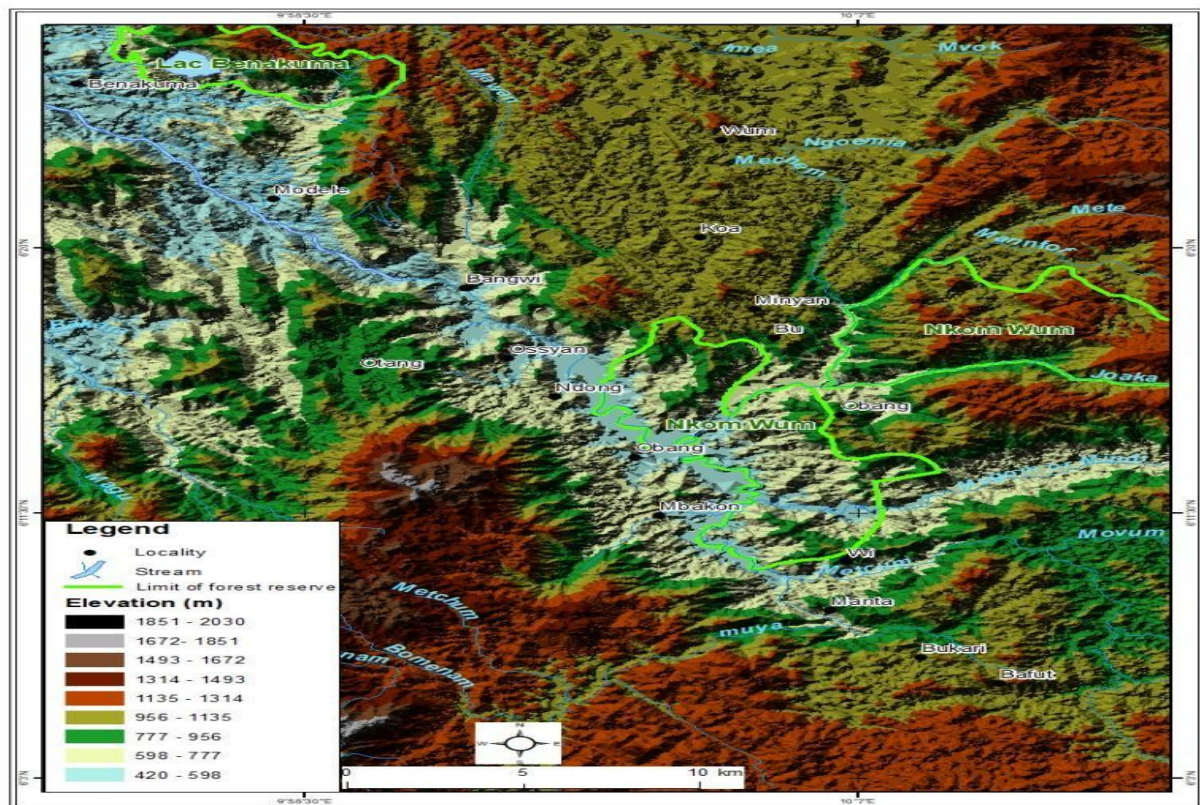
Figure 4: A 3D graphic of Bafut-Wum area Geologic maps by Soba (1989), Peronne (1969), Deruelle et al., (1991) and Gèze (1961) were also studied. However, working with these maps gave us only a rough approximation of the geology of the study route area because of their scales (Fig 5). Therefore, only a thorough field work confirmed the lithology of the area.

Slope angle as a property in initiating landslide has been studied by a number of researchers such as Bryant, 1991; Alexander, 1993. The 3D (see Fig 4) was projected and used in this study to analyze the topographic features of areas of these mountain forests road segment. All the landslides in the forests occurred on slopes 30⁰-90⁰.

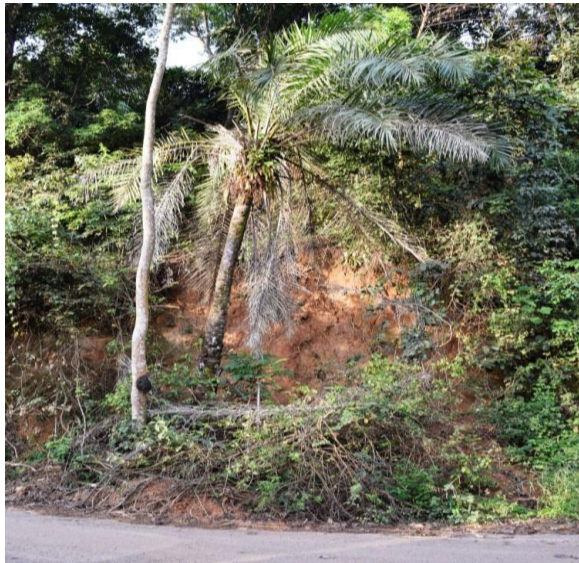
Figure 6a: Landslides of Bafut Forest

material void of any vegetation or is sparsely vegetated compared to adjacent areas (see Figure 6a). Along this stretch, at least 35 fresh landslide scarps were counted on the road embankment at the time of survey. The lengths of these slides from crown to accumulation area range from 1-16 m. The widths of these scarps ranged from 0.5 m to 20 m and depths range from about 0.5 m to 12 m. The run-out distance varies from a few centimetres where material is deposited at the foot of the embankment to 10 m and more where the material goes beyond the roadway into the adjacent ravine. The landslide material from the depletion area is dumped into the road gutter (where it is provided for) and/or carried onto the carriageway where it is abandoned as a hummocky accumulation and or beyond the road carriageway as shown in figure 6a and 6b.

According to the classification schemes of Varnes (1978) and Cruden and Varnes (1996) these failures are mainly translational debris slides as seen in Figure 6a and a few rotational slides as seen in Figure 6b. There are 32 translational slides recognized by their 'straight' slide planes. The 3 rotational slides reveal curved surface ruptured slide planes. Based on the classification of Rafek *et al.*, 1989 and that of Hutchinson, 1995 these landslides are mainly small volume and shallow landslides respectively. Based on travel distance (Moriwake (1987), Kusomoto *et al.* (2003), Usuki *et al.* (2011), Igwe and Fukoka (2014) and Igwe (2015), these landslides are short-distanced travelled landslides.

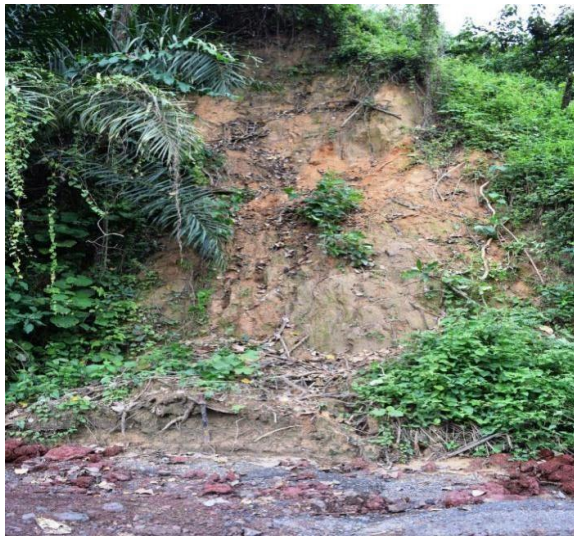
Figure 6c: Landslides of Befang Forest

According to the classification schemes of Varnes (1978) and Cruden and Varnes (1996), 14 of these landslides are translational debris slides revealing flat planar slide planes (figure 6c and 6d) and the rest are rotational slides. Most of the translational debris slides have incomplete depletion zones. Based on the classification of Rafek *et al.*, 1989 and that of Hutchinson, 1995 these landslides are mainly small volume and shallow landslides respectively. Based on travel distance (Moriwake (1987), Kusomoto *et al.*, (2003), Usuki *et al.*, (2011), these landslides are short-distanced travelled landslides.

The relatively new slides show sharp and barren scarp features with steep gradients. Landslide materials are abandoned as heaps or hummocky deposits on the road carriageway or fills up the gutter where one is present as in figure 6a. The residual soil material caps a granite bedrock from which it developed and also constitute the main bulk of the landslide material.

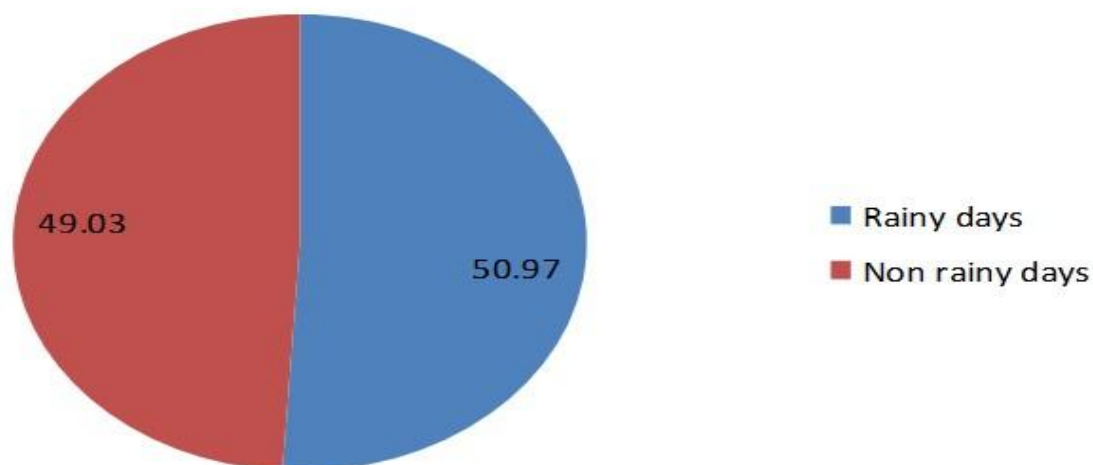
Figure 8: Pie chart representation of percentage of rainy days of the year.

According to tables 6 and 7 and figures 8 and 9, it can be realized that rainfall is likely to occur every month of the year. This ensures a minimum volume of water held by the soils before the main rainy season. The months of June, July, August and September contribute more than 60% to the annual rainfall budget. The annual average rainfall for this region as calculated is 2400 mm (Bamenda Meteorological Station). This annual average far exceeds the averages in other parts of the world where rainfall is known for triggering or inducing landslides.

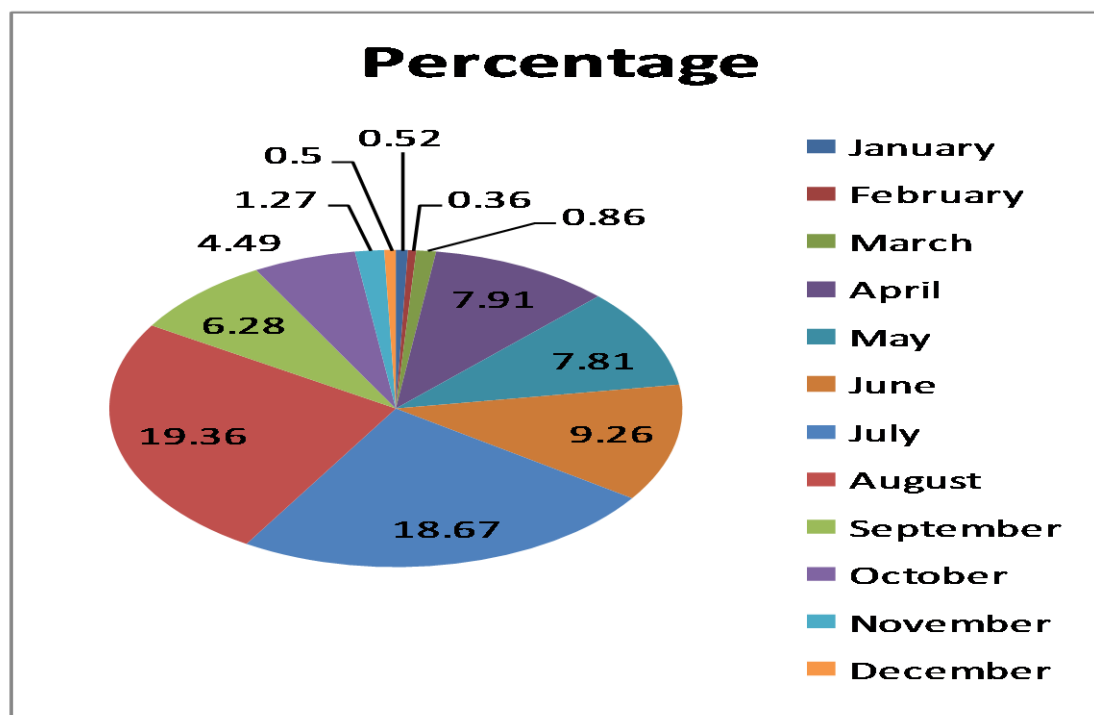
Figure 9: Pie chart representation of monthly contributions to the annual rainfall budget

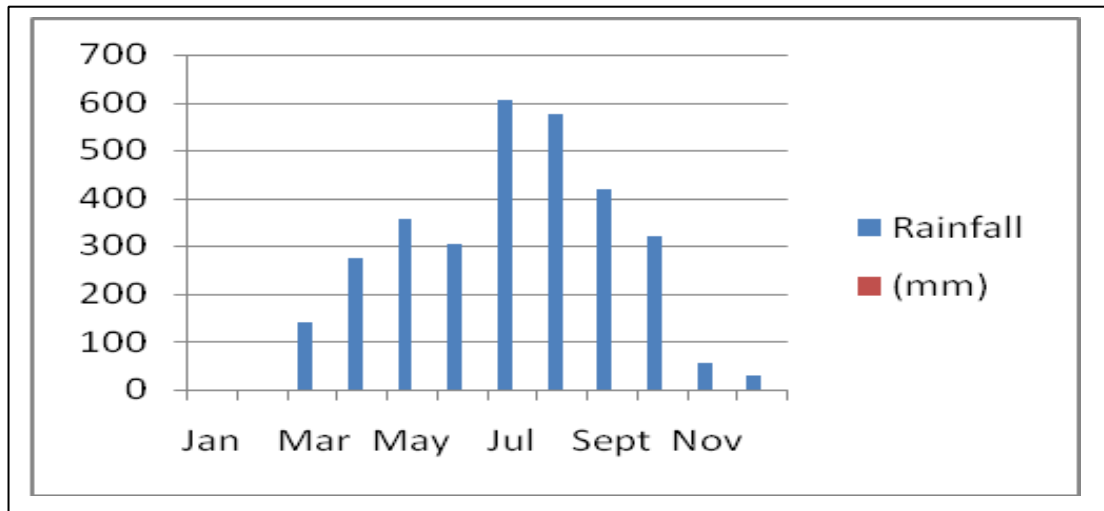
Figure 10: Monthly rainfall contributions 1988. Wum
